# REGREENING OF THE NORTHERN ETHIOPIAN MOUNTAINS: EFFECTS ON FLOODING AND ON WATER BALANCE

KEY WORDS: HYDRO-GEOMORPHOLOGY, REFORESTATION, CREST STAGE, PEAK DISCHARGE, BEDLOAD

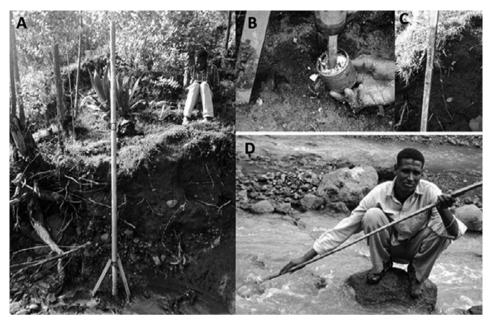
**Figure 4:** Crest stage gauge (A), sawdust being placed in the bowl of the lower cap before and after measuring peak stage (B), remnants of sawdust on wood staff indicating the highest peak stage of the flood (C), and wood staff being cleaned for the next flood (D).

Runoff response of catchments can be directly measured in different conventional ways. In the case of mountainous streams, however, direct measurement during the floods presents many challenges mainly due to the flash rate of the flow and its destructive character (WMO, 2008; Lumbroso and Gaume, 2012). Hence, it is frequently impossible or impractical to measure the peak discharges when they occur because of conditions beyond human control (Rantz, 1982). When such conditions occur, peak discharges in steep mountain streams are indirectly estimated after floods (Lumbroso and Gaume, 2012). In the current study, peak stage discharges were measured in the rainy seasons of 2012, 2013 and 2014 using 11 crest stage gauges (Waltermeyer, 2008) (Figure 4) which were installed in the outlets of the catchments.

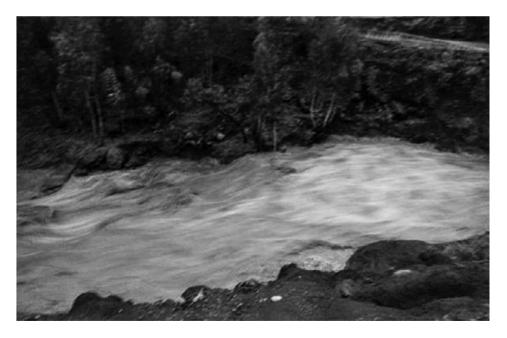
**Figure 5:** Intensive rainfall event of 21.1 mm (occurred in a very short period) in Wera' catchment (23/8/2013) produced a strong flash flood of 128 m $^3$  s $^{-1}$  at the monitoring station. Crest stage gauge appears in the middle of the opposite bank.

The peak stage data were collected after runoff events (Figure 5). Each station was visited at least once a week on a rotational basis whereby recorded peak stage was associated with the largest precipitation event in the intervening period and a total of 332 measurements were carried out. Based on the daily peak stage data, peak discharge events were computed using the Manning's equation which is the most commonly used hydraulic technique for estimating open channel flow for uncalibrated section (Jarrett, 1984; Lumbroso and Gaume, 2012; Karalis *et al.*, 2014):
